Merseyside Fire & Rescue Service
BESS Thermal Event, Carnegie Rd, Liverpool
15th September 2020

Station Manager John O'Boyle

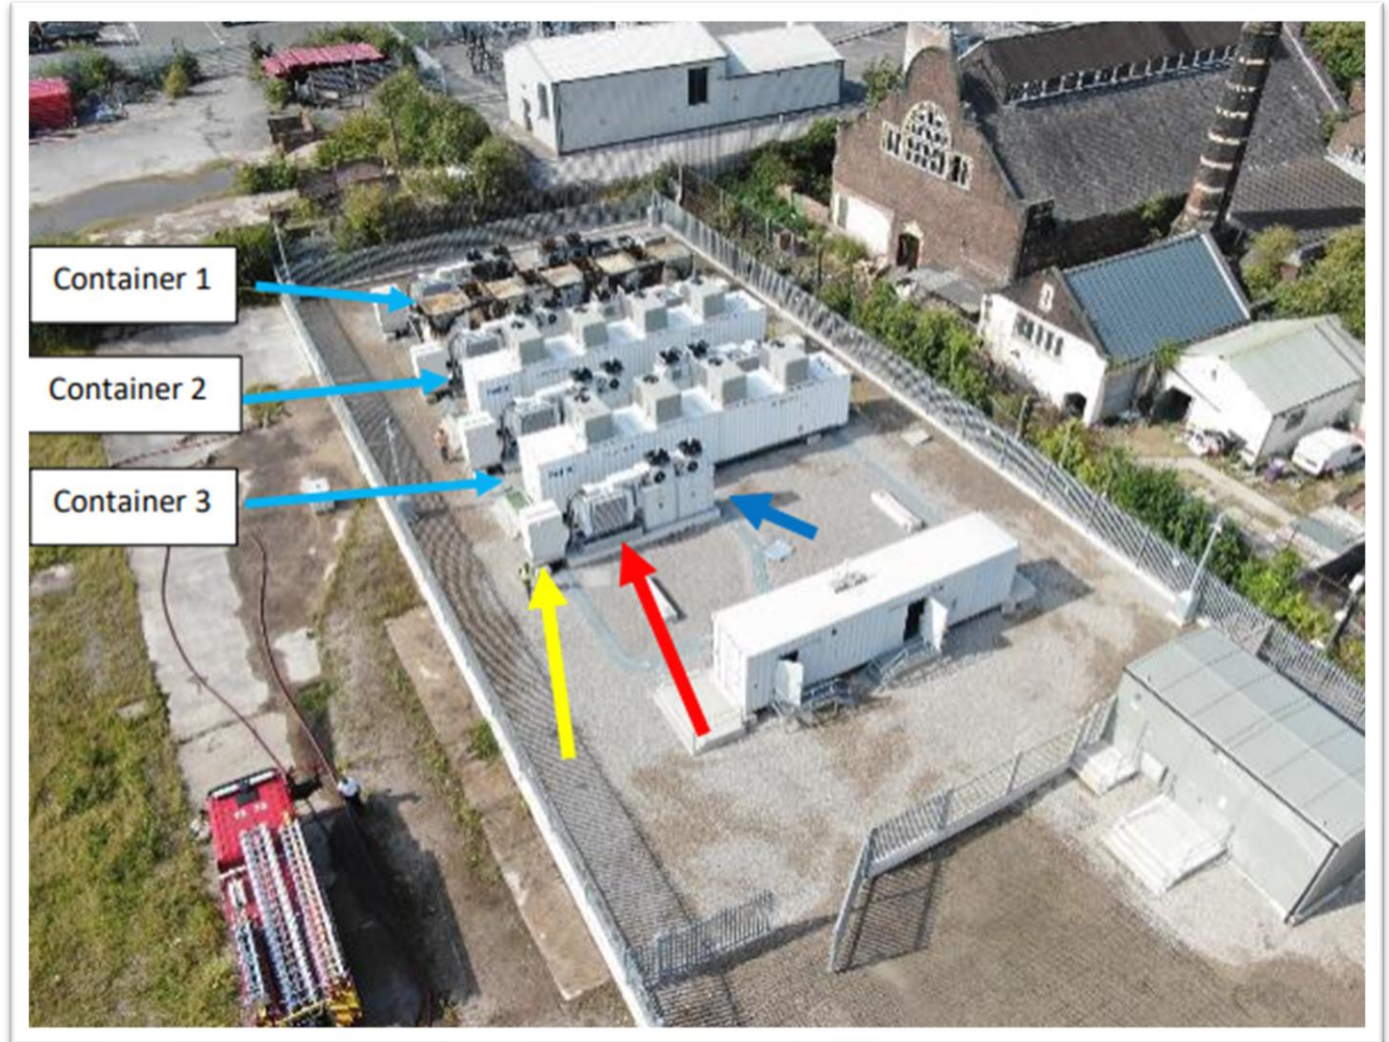
- Next to each BESS is a high voltage switch Ring Main Unit (RMU) (yellow arrow on the photograph),
- Transformer 33kV – 415V (red arrow on the photograph)
- A cooler inverter (blue arrow on the photograph).
- On the top of the BESS containers are four HVAC systems.

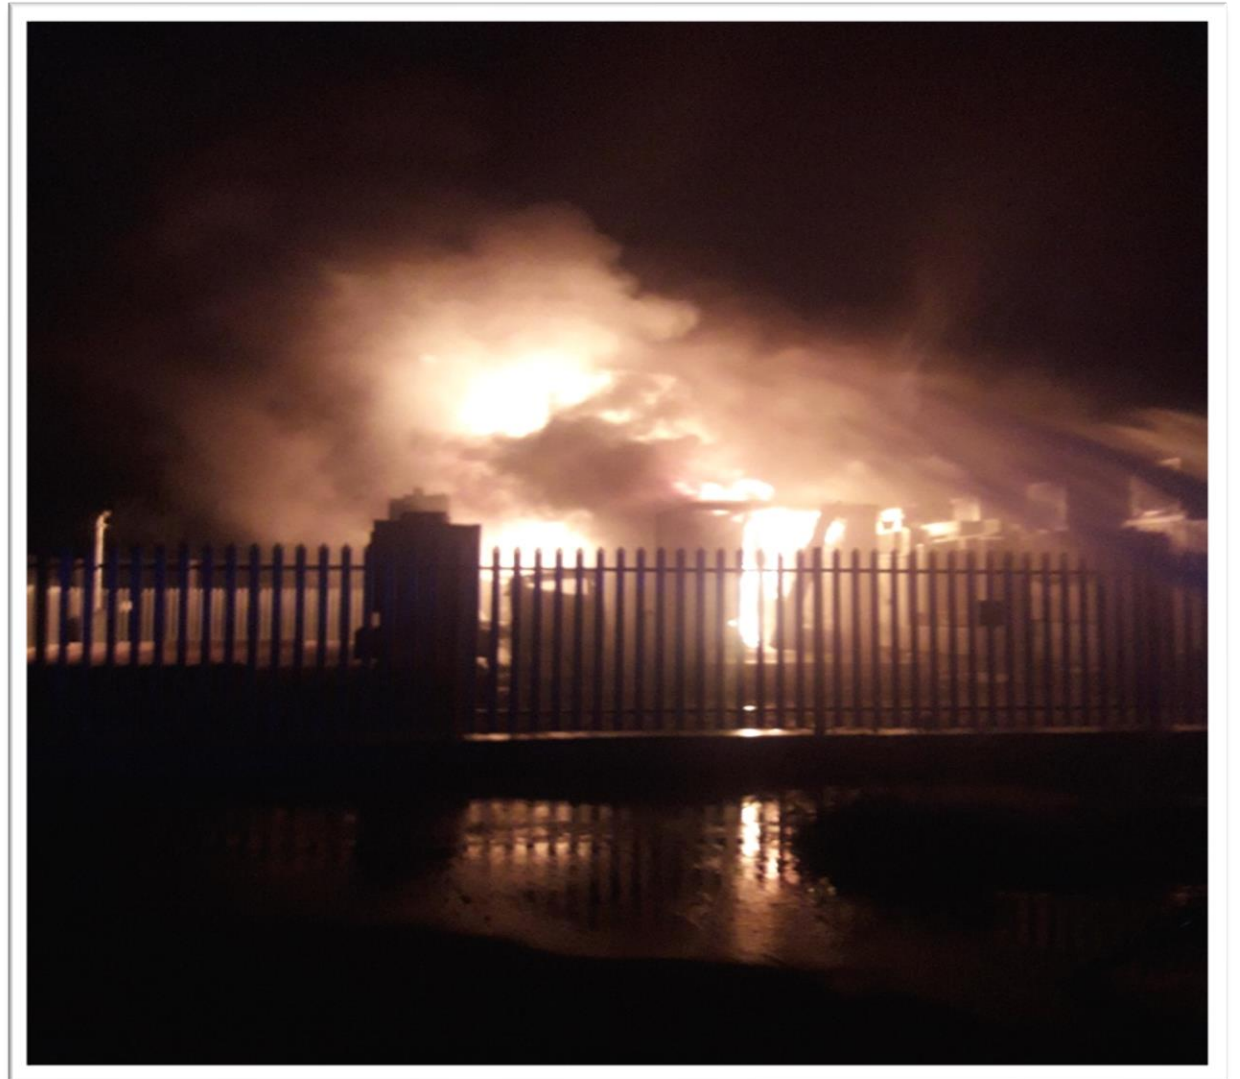
MFRS incident: 15th September 2020

- Call received at 00:49hrs
- Reports of explosion
- Potential Vapour Cloud Explosion (VCE)
- Initial attendance 2 pumps
- Initial discovery of powerful, well developed fire.
- Evidence of blast – debris
- Make pumps 5 for water
- SM and HMA requested
- Image approximately 01:30hrs
- Wind speed 8kph, 16 C, Clear sky

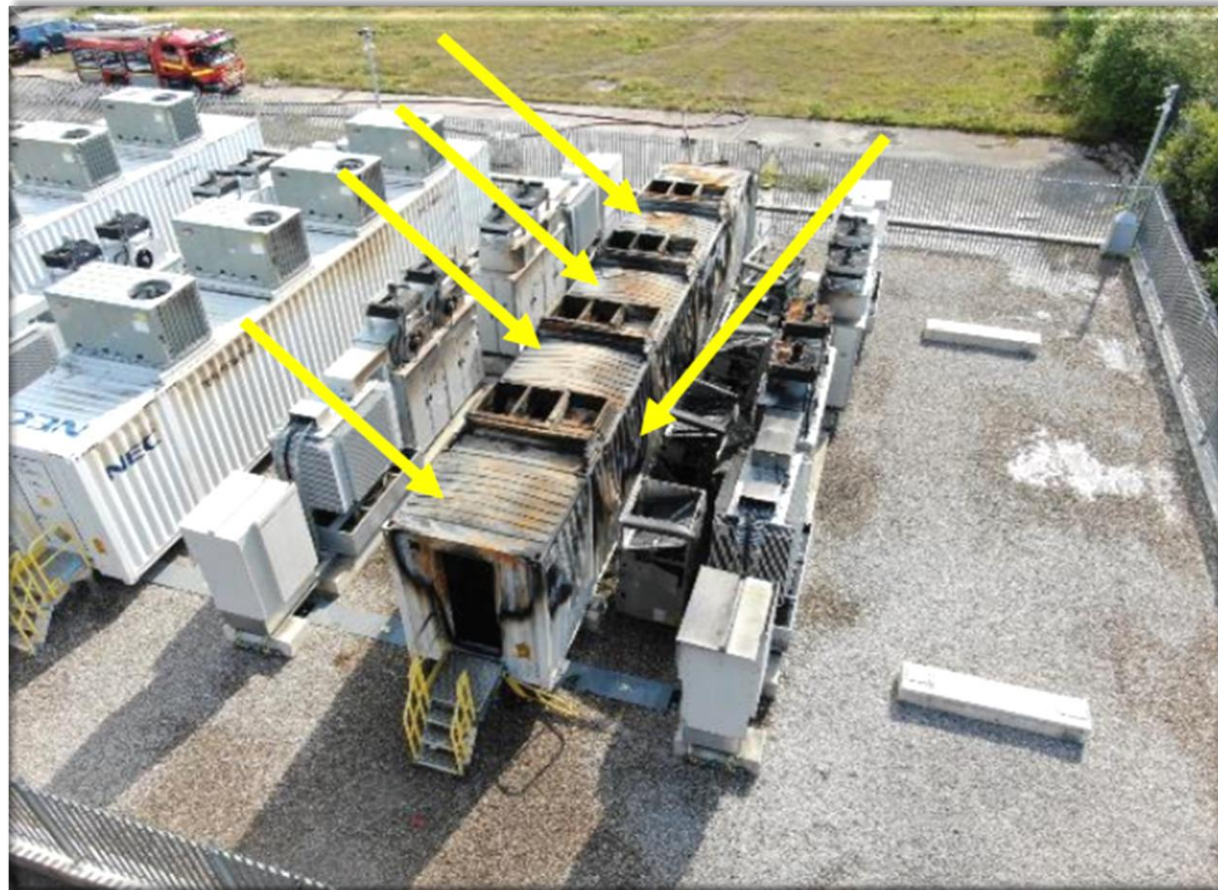
The Image shows the damaged container with signs of expansion/distortion that is equal across the container and not localised to the area of the initial failure

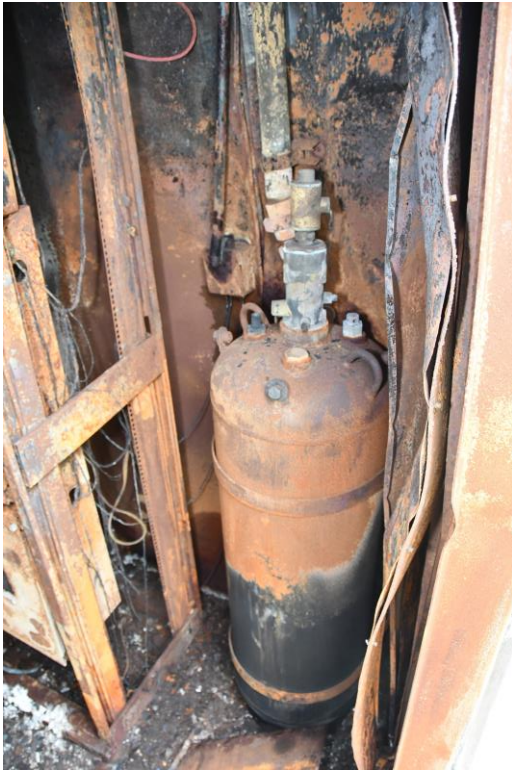
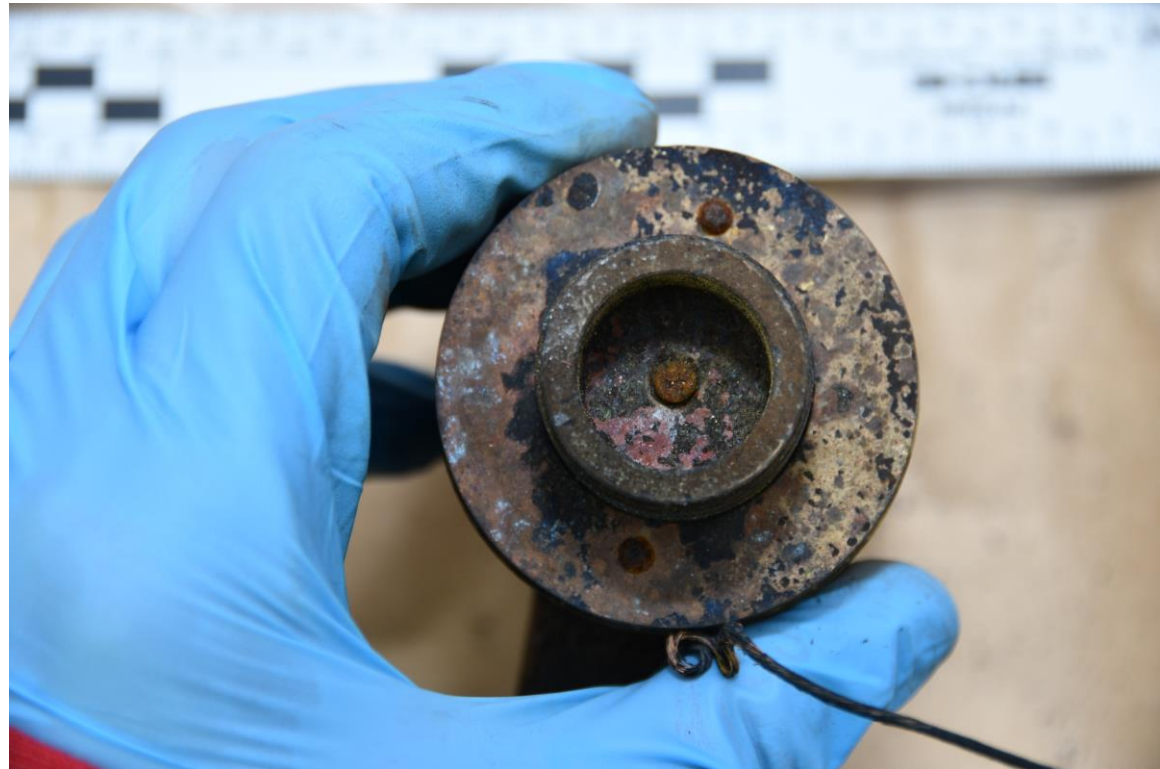
Suppression system

- Due to Covid, a joint inspection was conducted remotely of the suppression system which showed that the firing pin had activated.

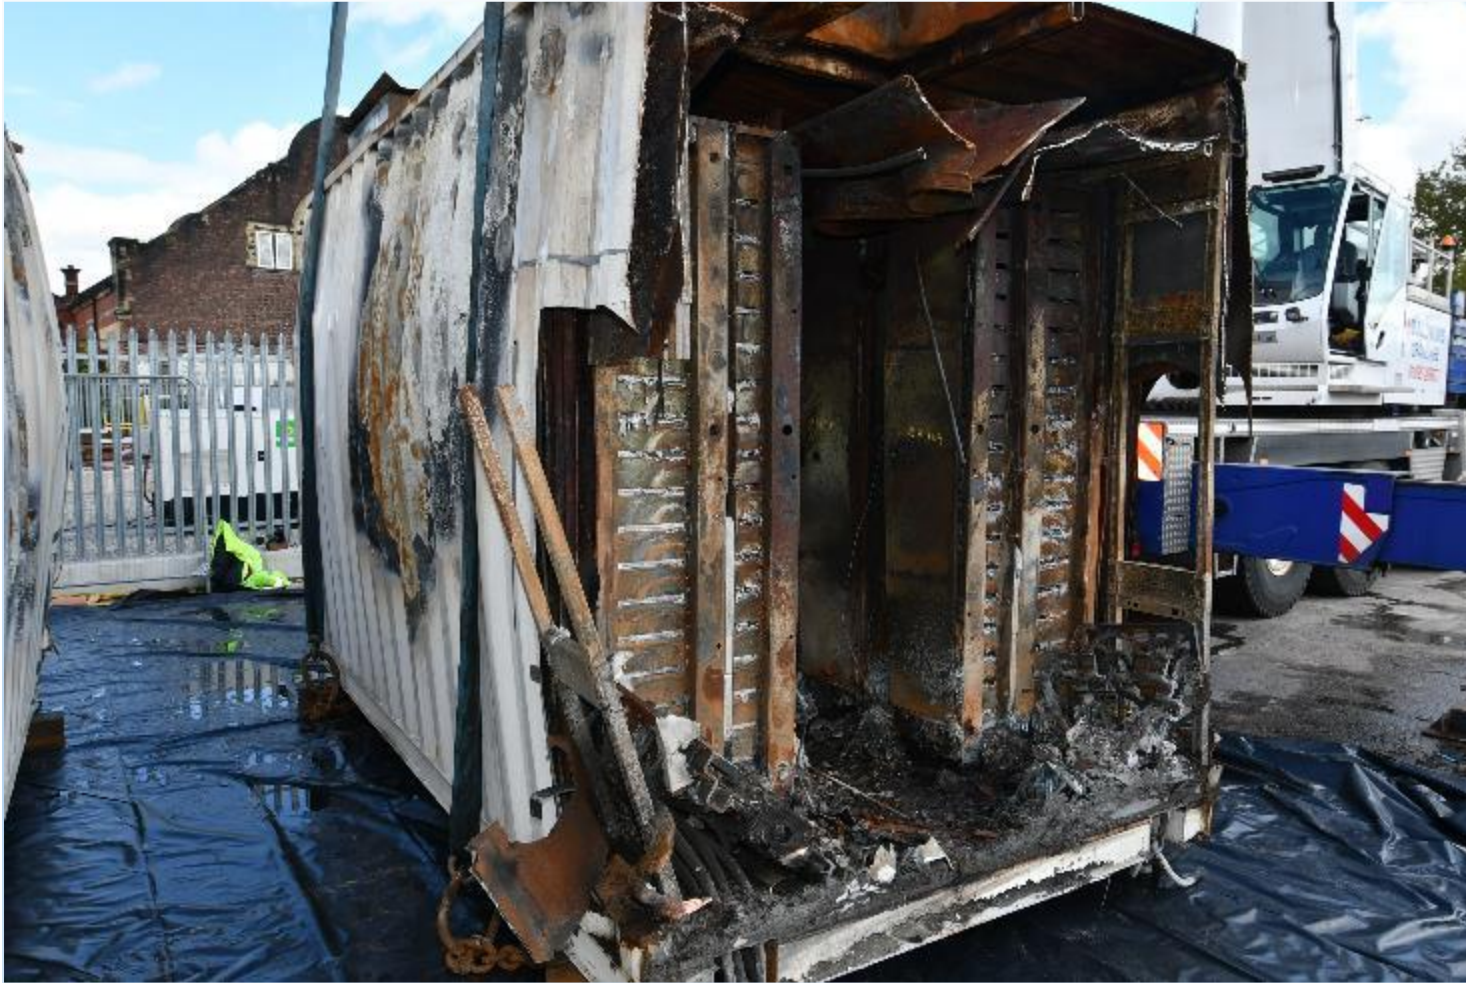
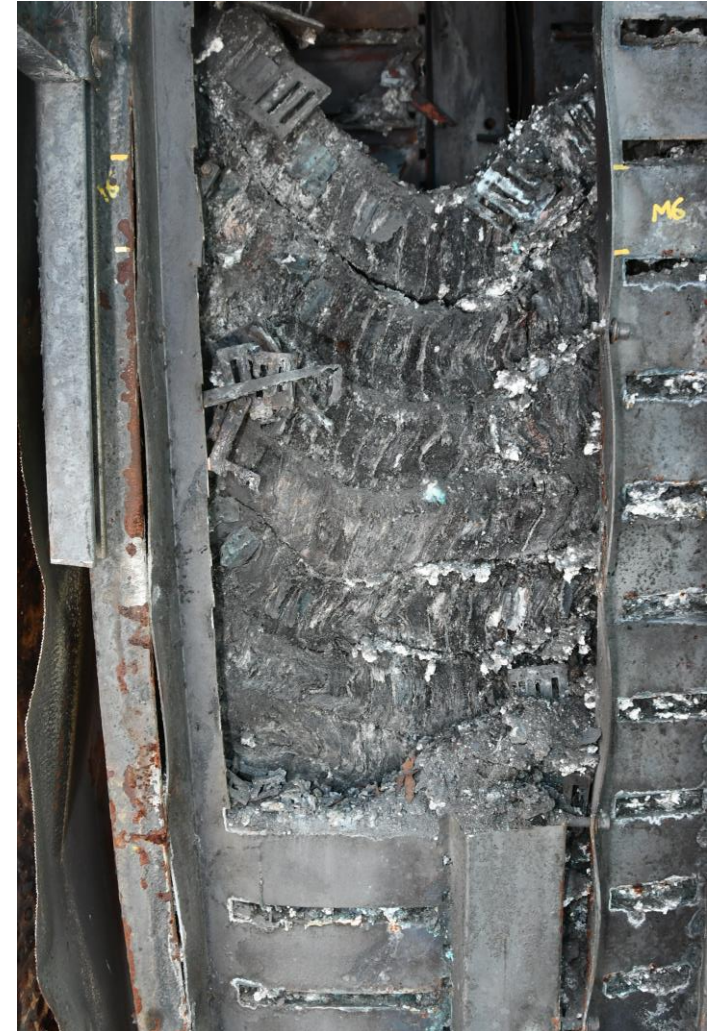
Physical examination

- Once a physical examination of the container was cleared an inspection hatch was made next to the area of origin
- When this area had been cleared the container was cut into three sections
- This gave access to the rack and module of interest
- Due to the extent of fire damage the investigation team removed the module of interest which was sent for scanning.

The explosion was a result of a failure within Battery Zone 3-Rack 7 Module 6 (BZ3-R7M6) which led to thermal runaway, which, in turn produced gases within the container culminating in a deflagration.
