Merseyside Fire & Rescue Service
BESS Thermal Event, Carnegie Rd, Liverpool
15th September 2020

Station Manager John O'Boyle

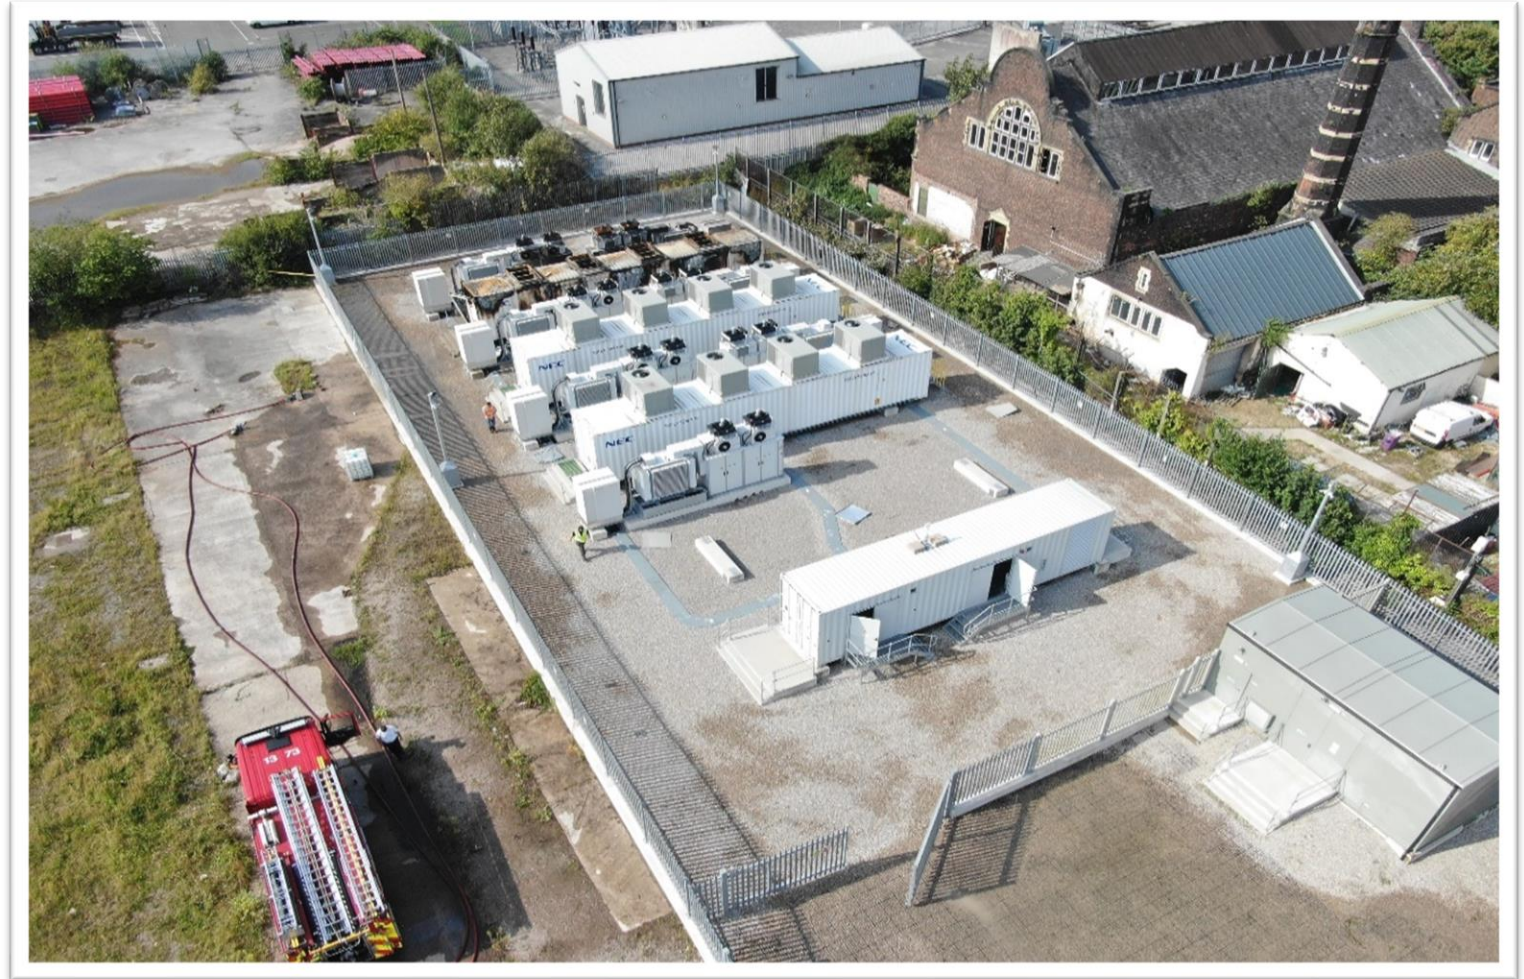
- Next to each BESS is a high voltage switch Ring Main Unit (RMU) (yellow arrow on the photograph),
- Transformer 33kV – 415V (red arrow on the photograph)
- A cooler inverter (blue arrow on the photograph).
- On the top of the BESS containers are four HVAC systems.

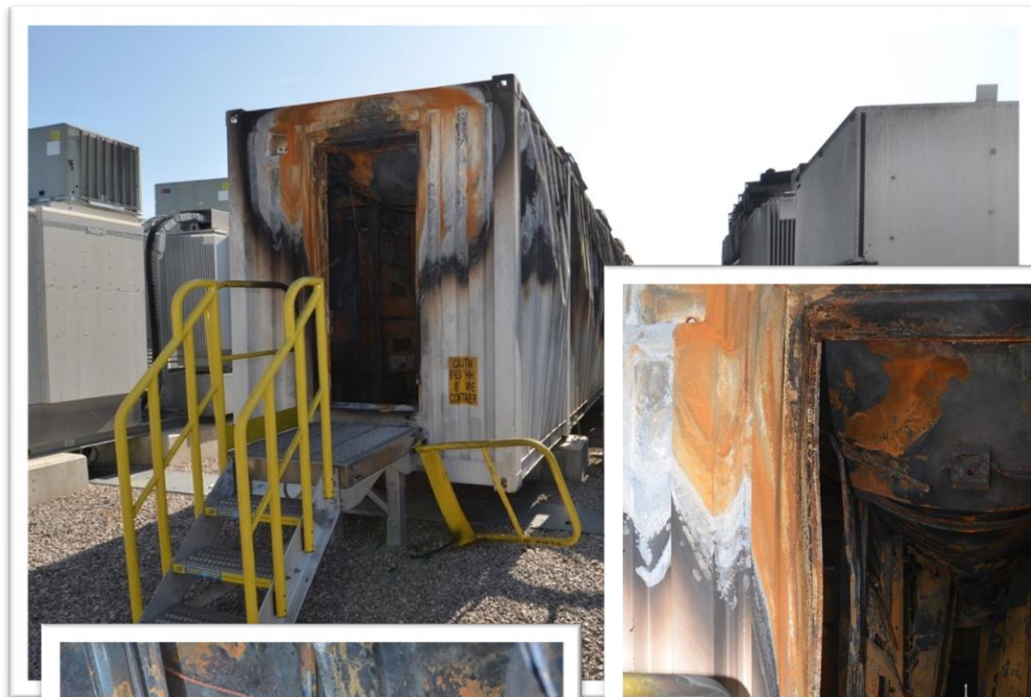
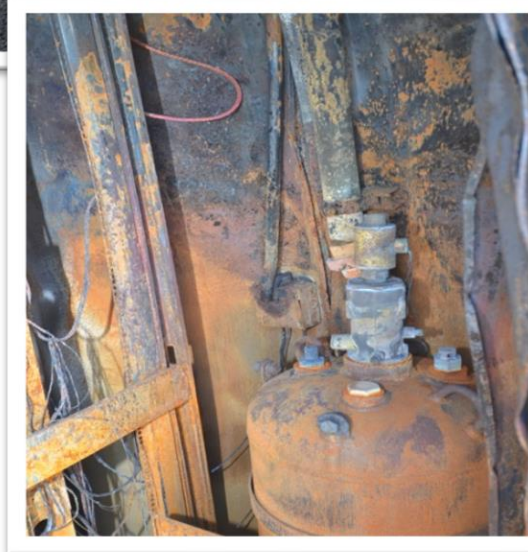
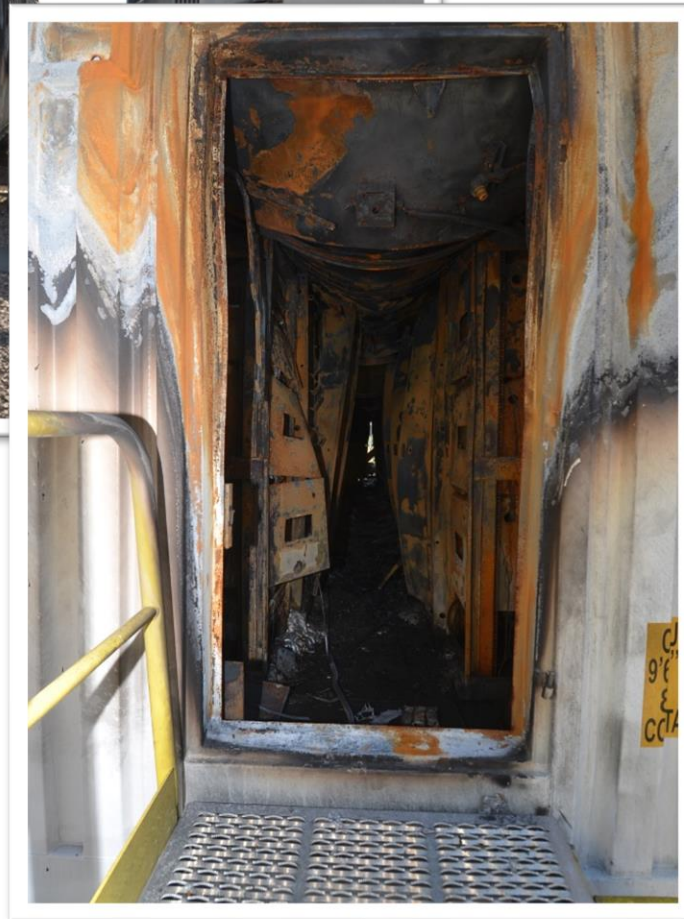
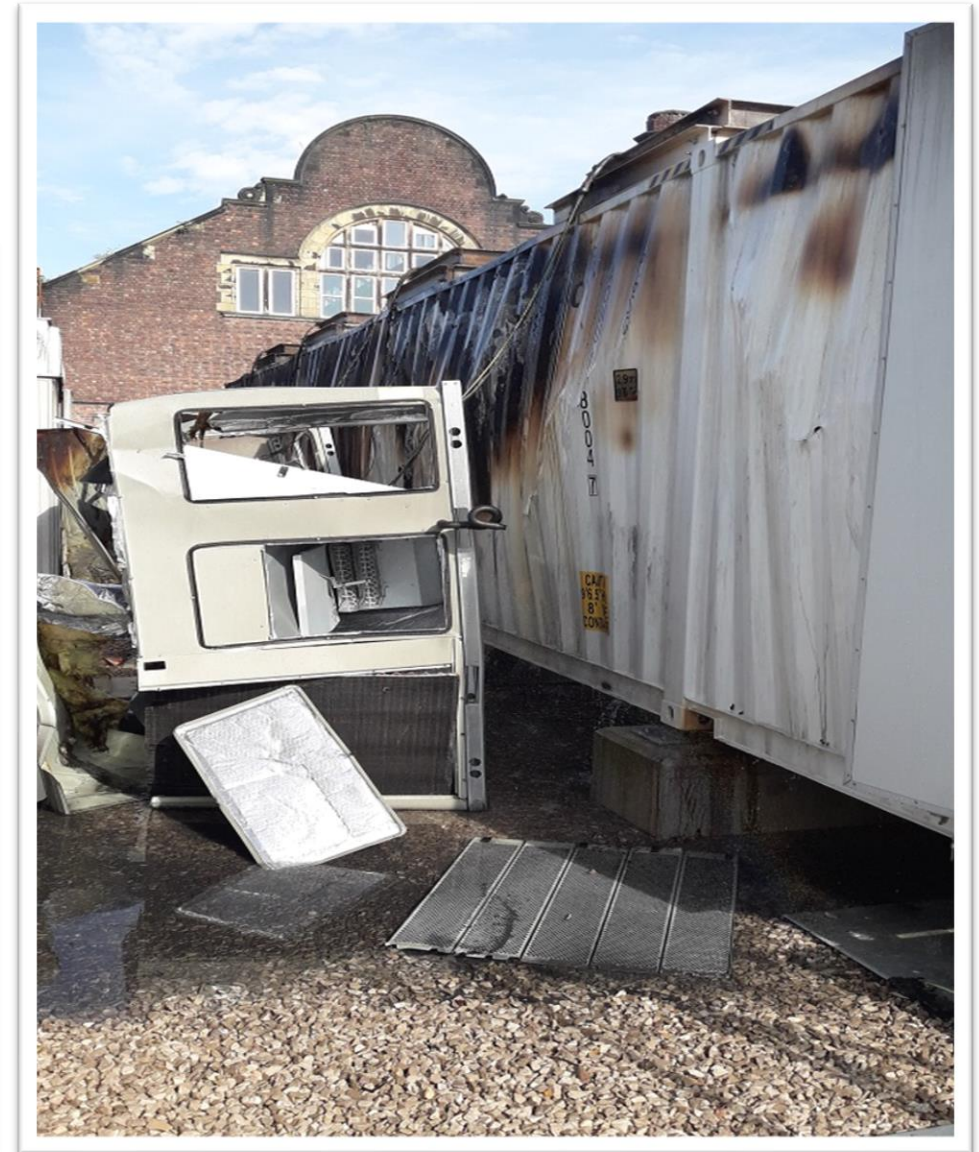
Incident Investigation imagery:

The Image shows the damaged container with signs of expansion/distortion that is equal across the container and not localised to the area of the initial failure

The explosion was a result of a failure within Battery Zone 3-Rack 7 Module 6 (BZ3-R7M6) which led to thermal runaway, which, in turn produced gases within the container culminating in a deflagration.
